## SUMMARY REPORTS of RECENT EARTHQUAKES inTURKEY

**Prof. Dr. Nesrin YARDIMCI**  
**Assist. Prof. Dr. Pınar ÖZDEMİR**  
**Res. Assist. Cüneyt VATANSEVER**

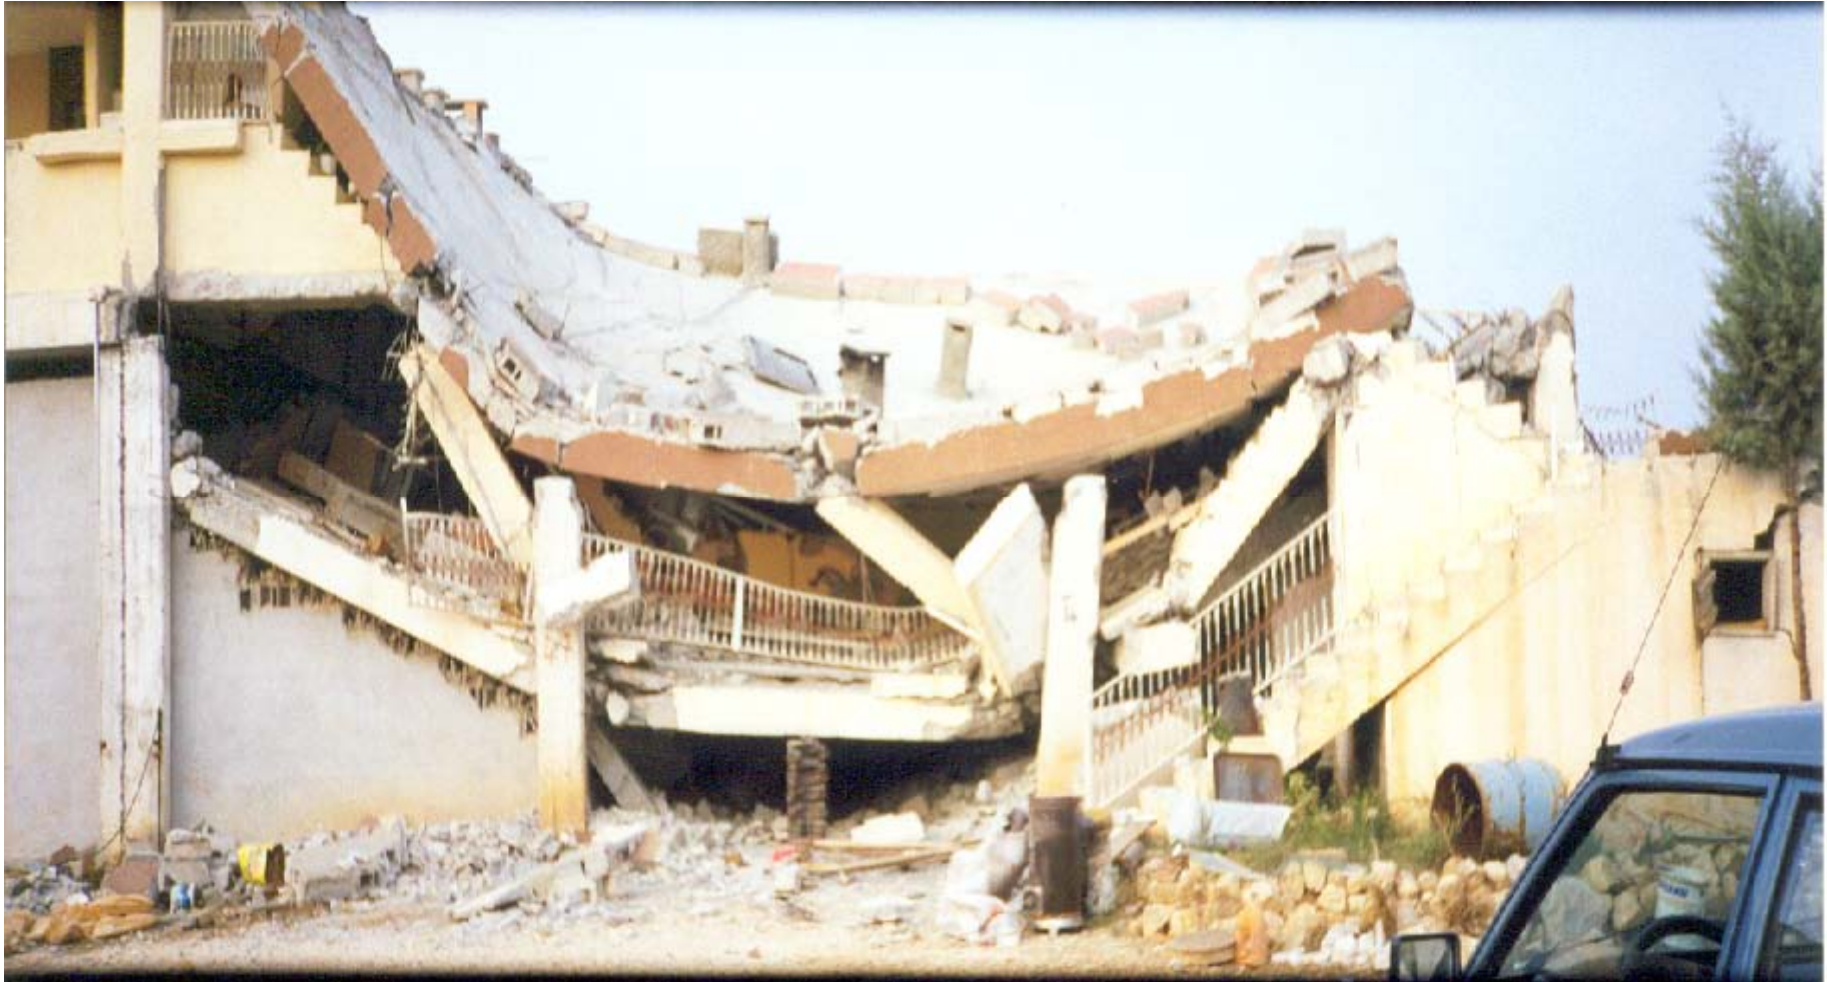
**Collapsed Gable and Parapet Wall of The Police  
Headquarters ( Bayulke,1998 )**

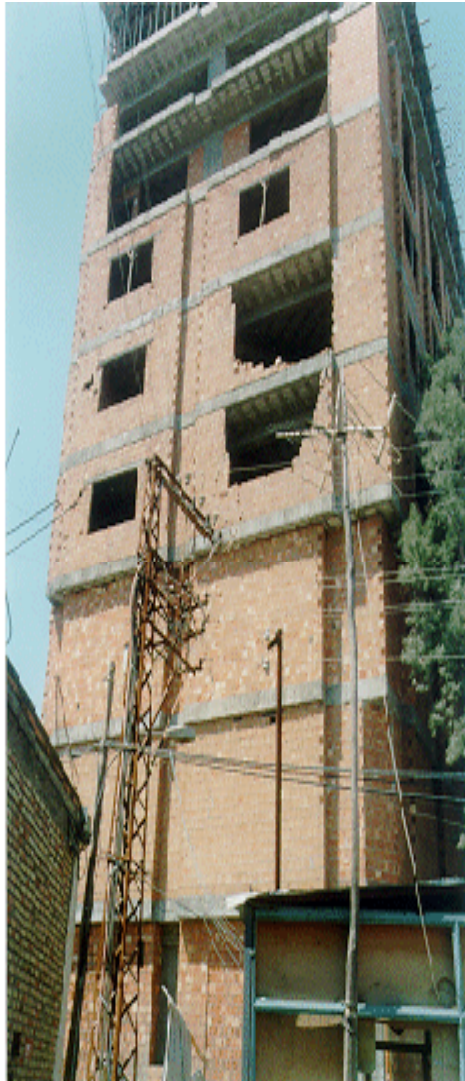
**Collapsed Facade  
Walls,  
Story Height > 3.60  
meters.  
Filler Block Joist Slab,  
at Ceyhan  
(Bayulke, 1998)**

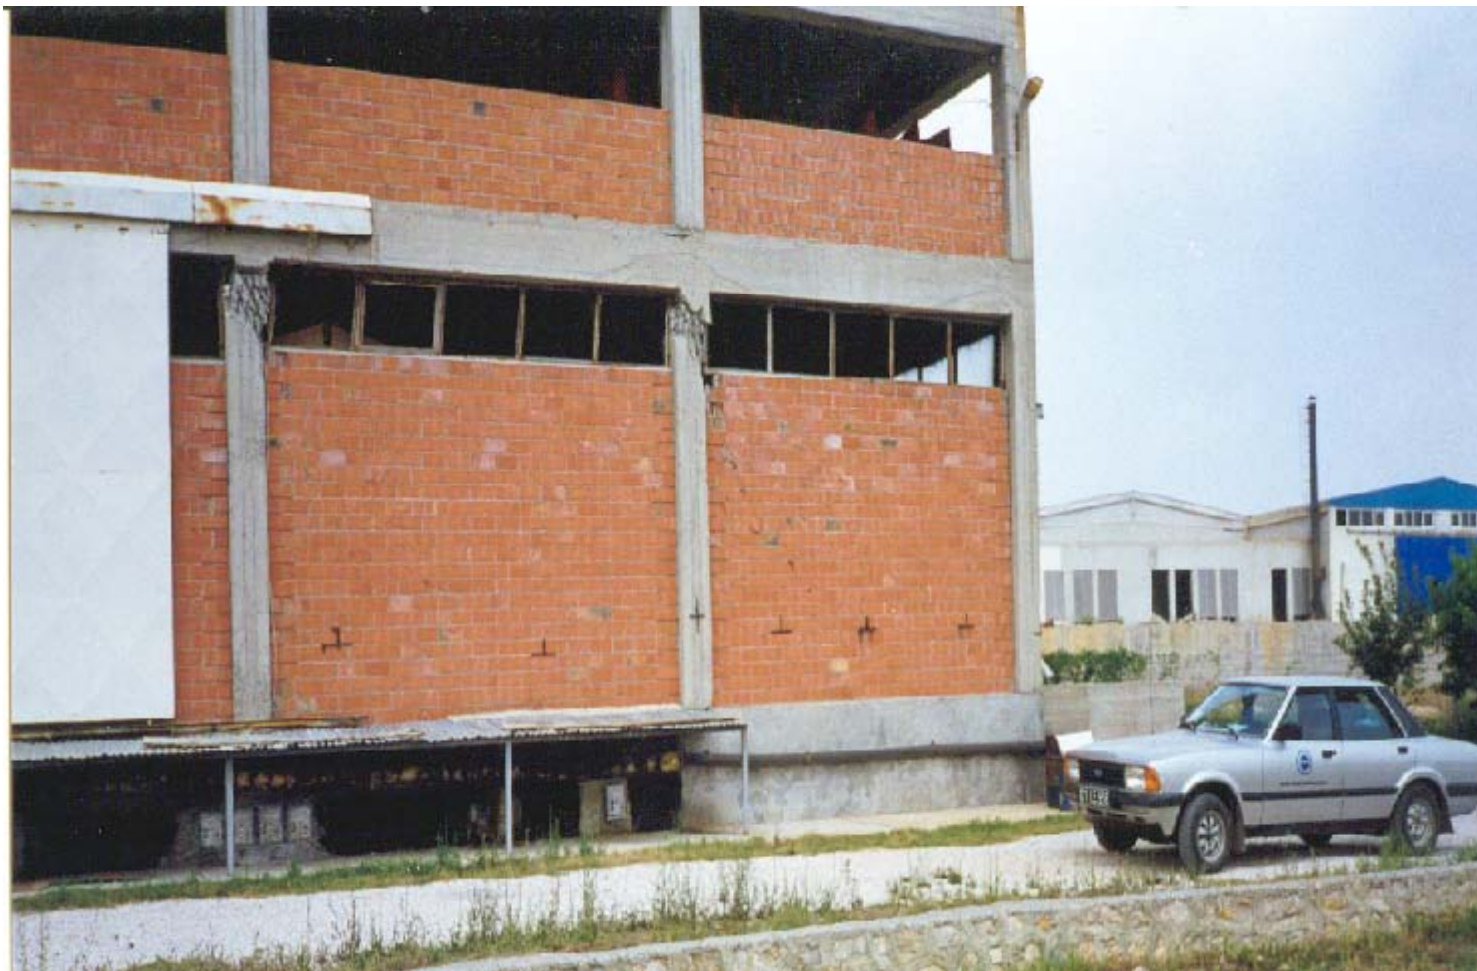
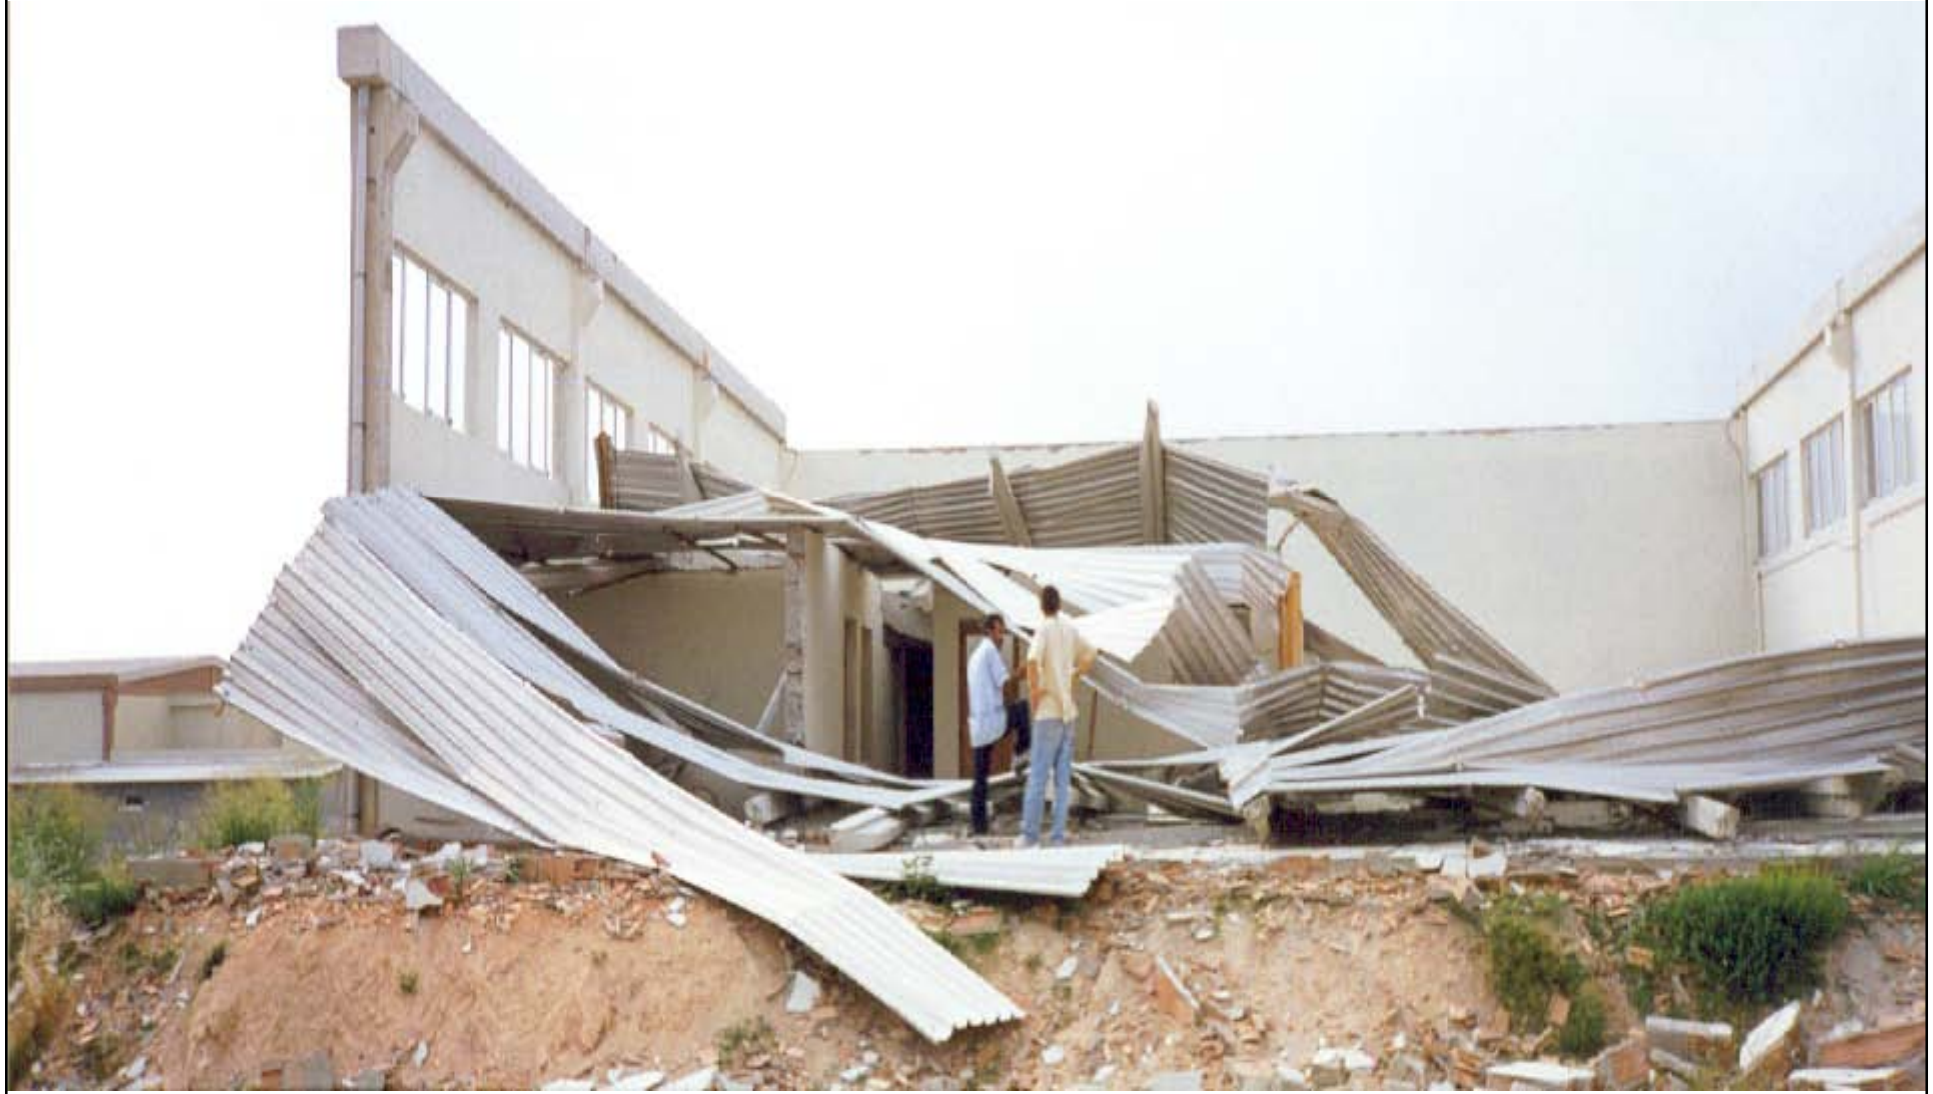
**The Adana-Ceyhan Earthquake effected large number of single story factory and warehouse buildings constructed with prefabricated reinforced concrete elements and the behavior of prefabricated system indicated serious deficiencies.**

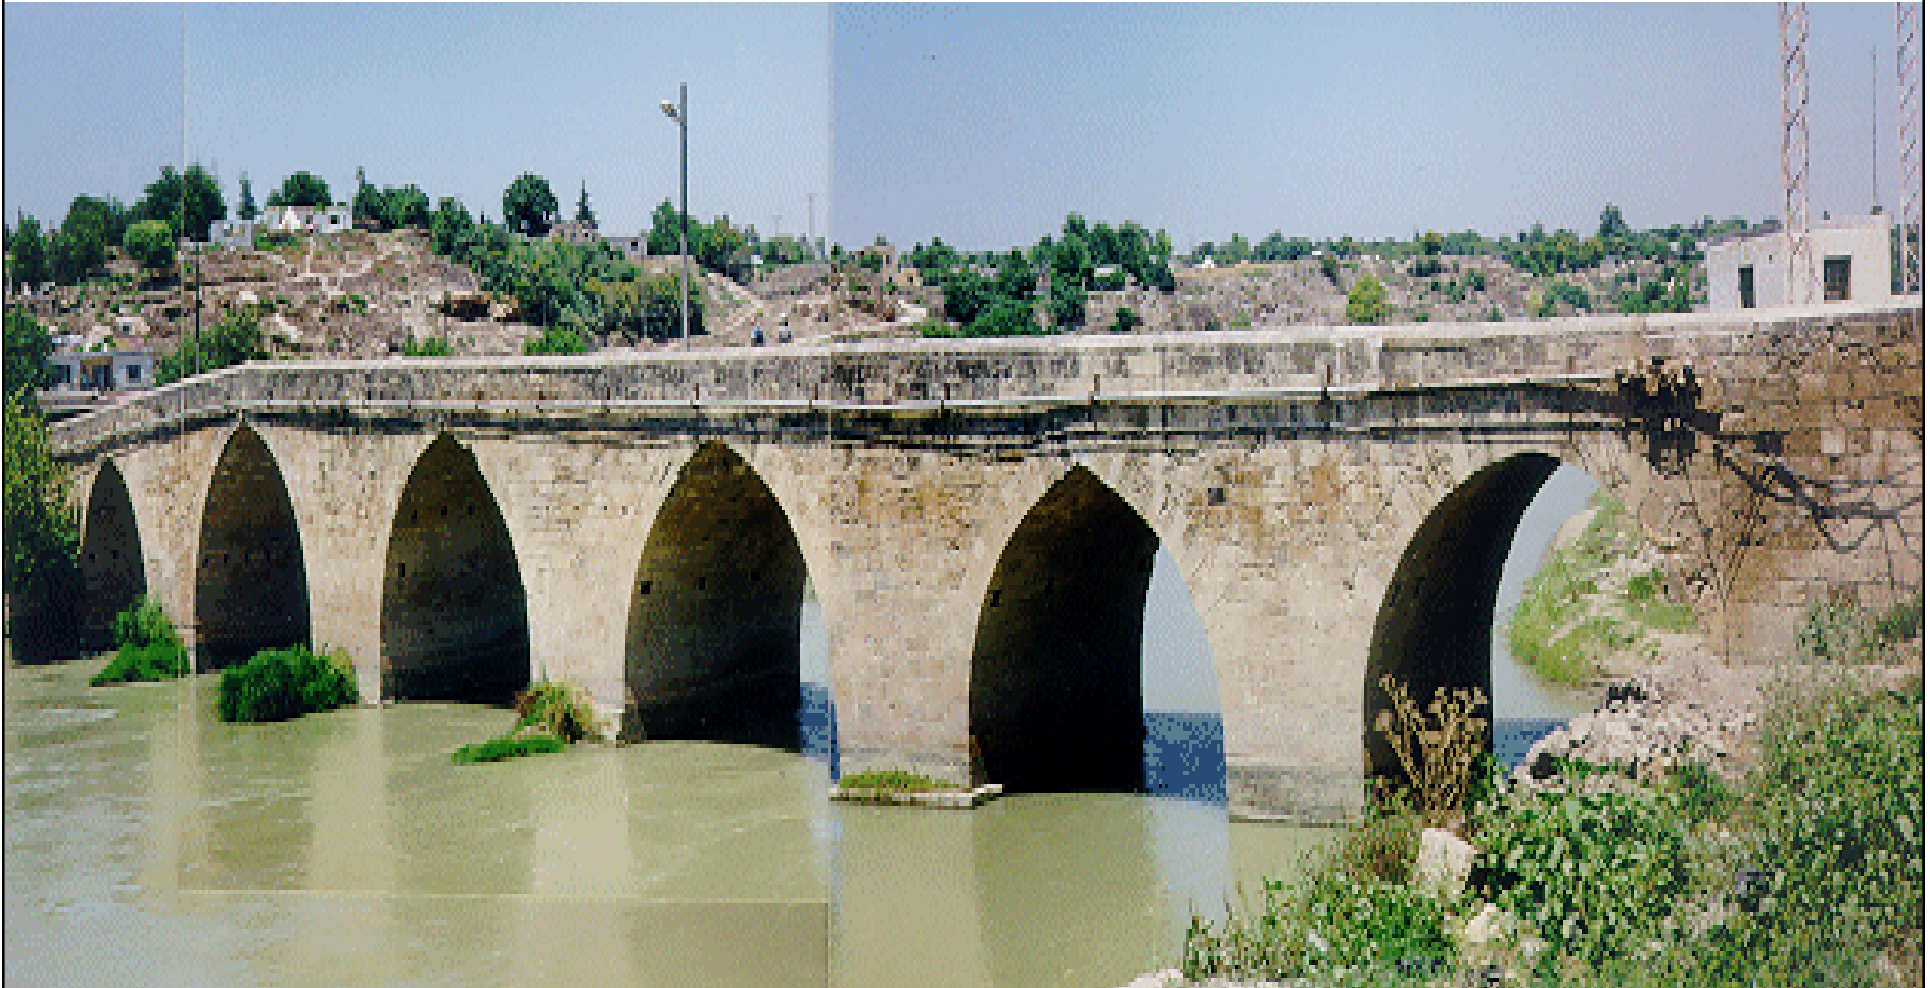
**No bridge had been damaged on the Ceyhan River except an historical stone arch bridge, Misis, that had been constructed in IV Century AC, and it was partially damaged.**

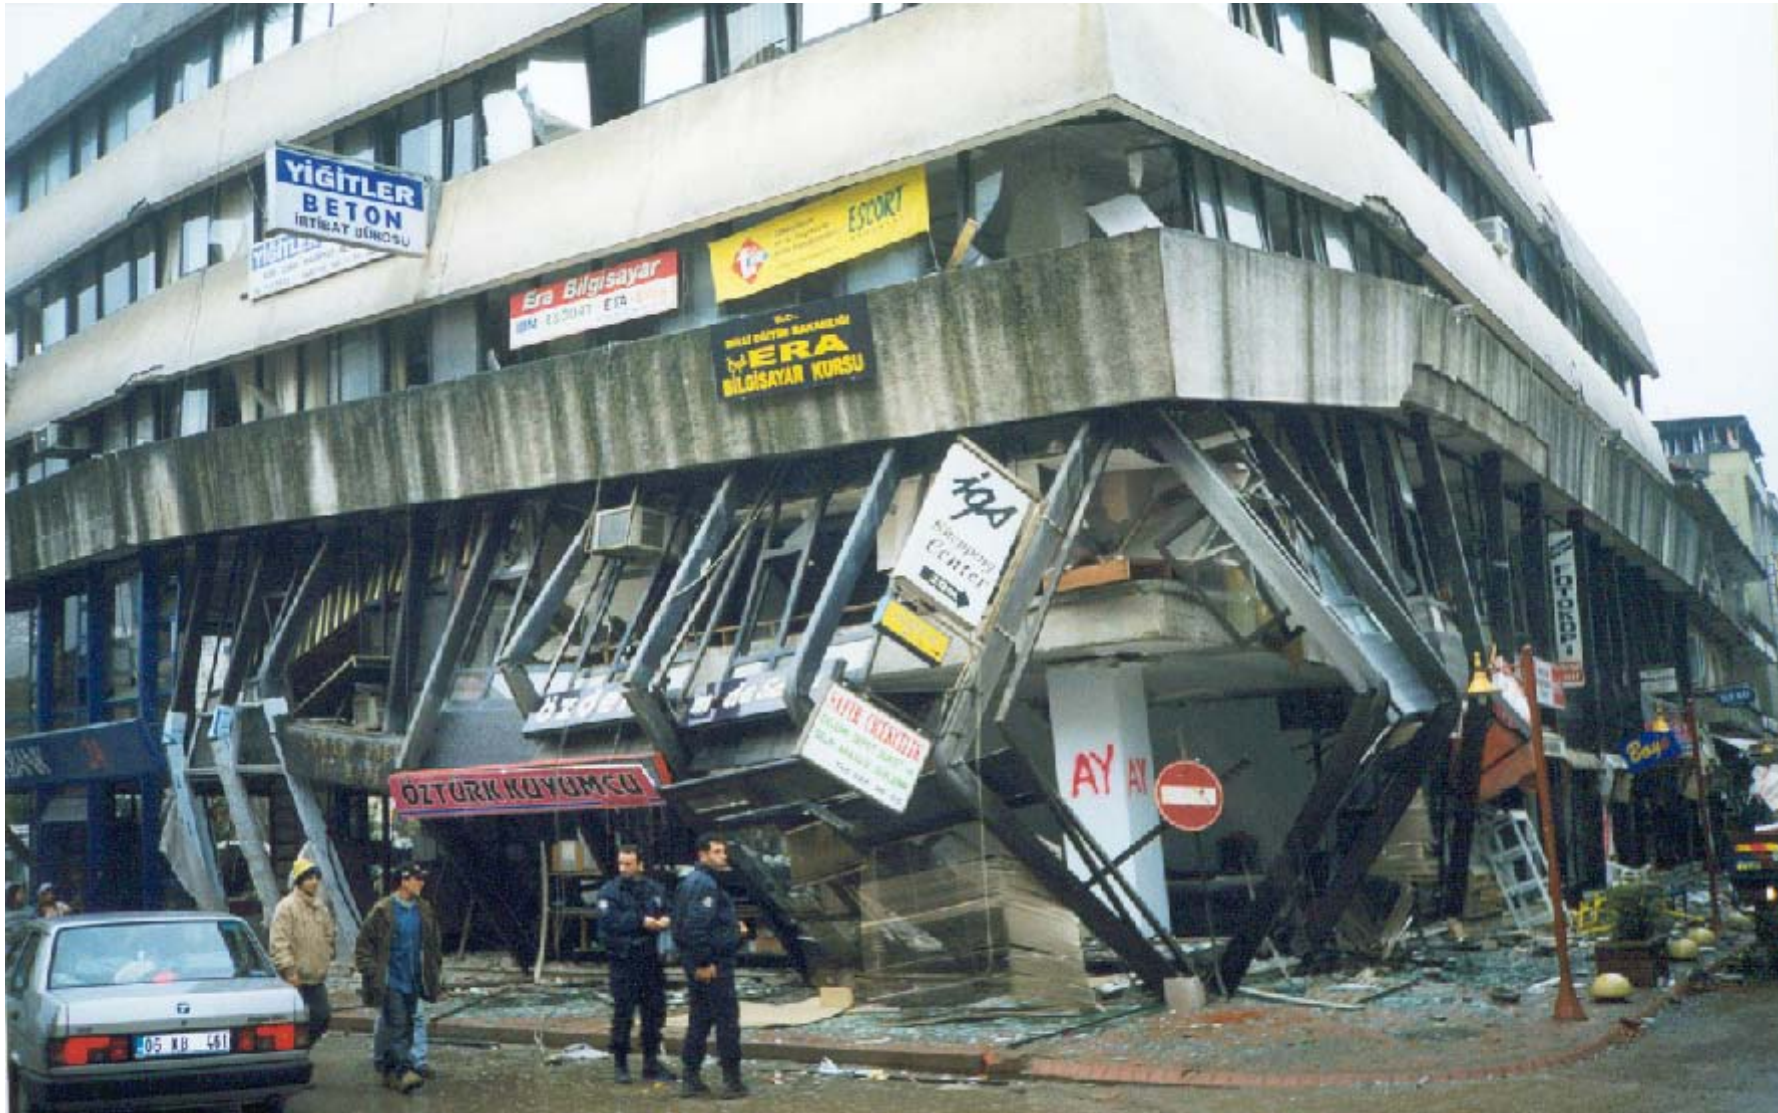
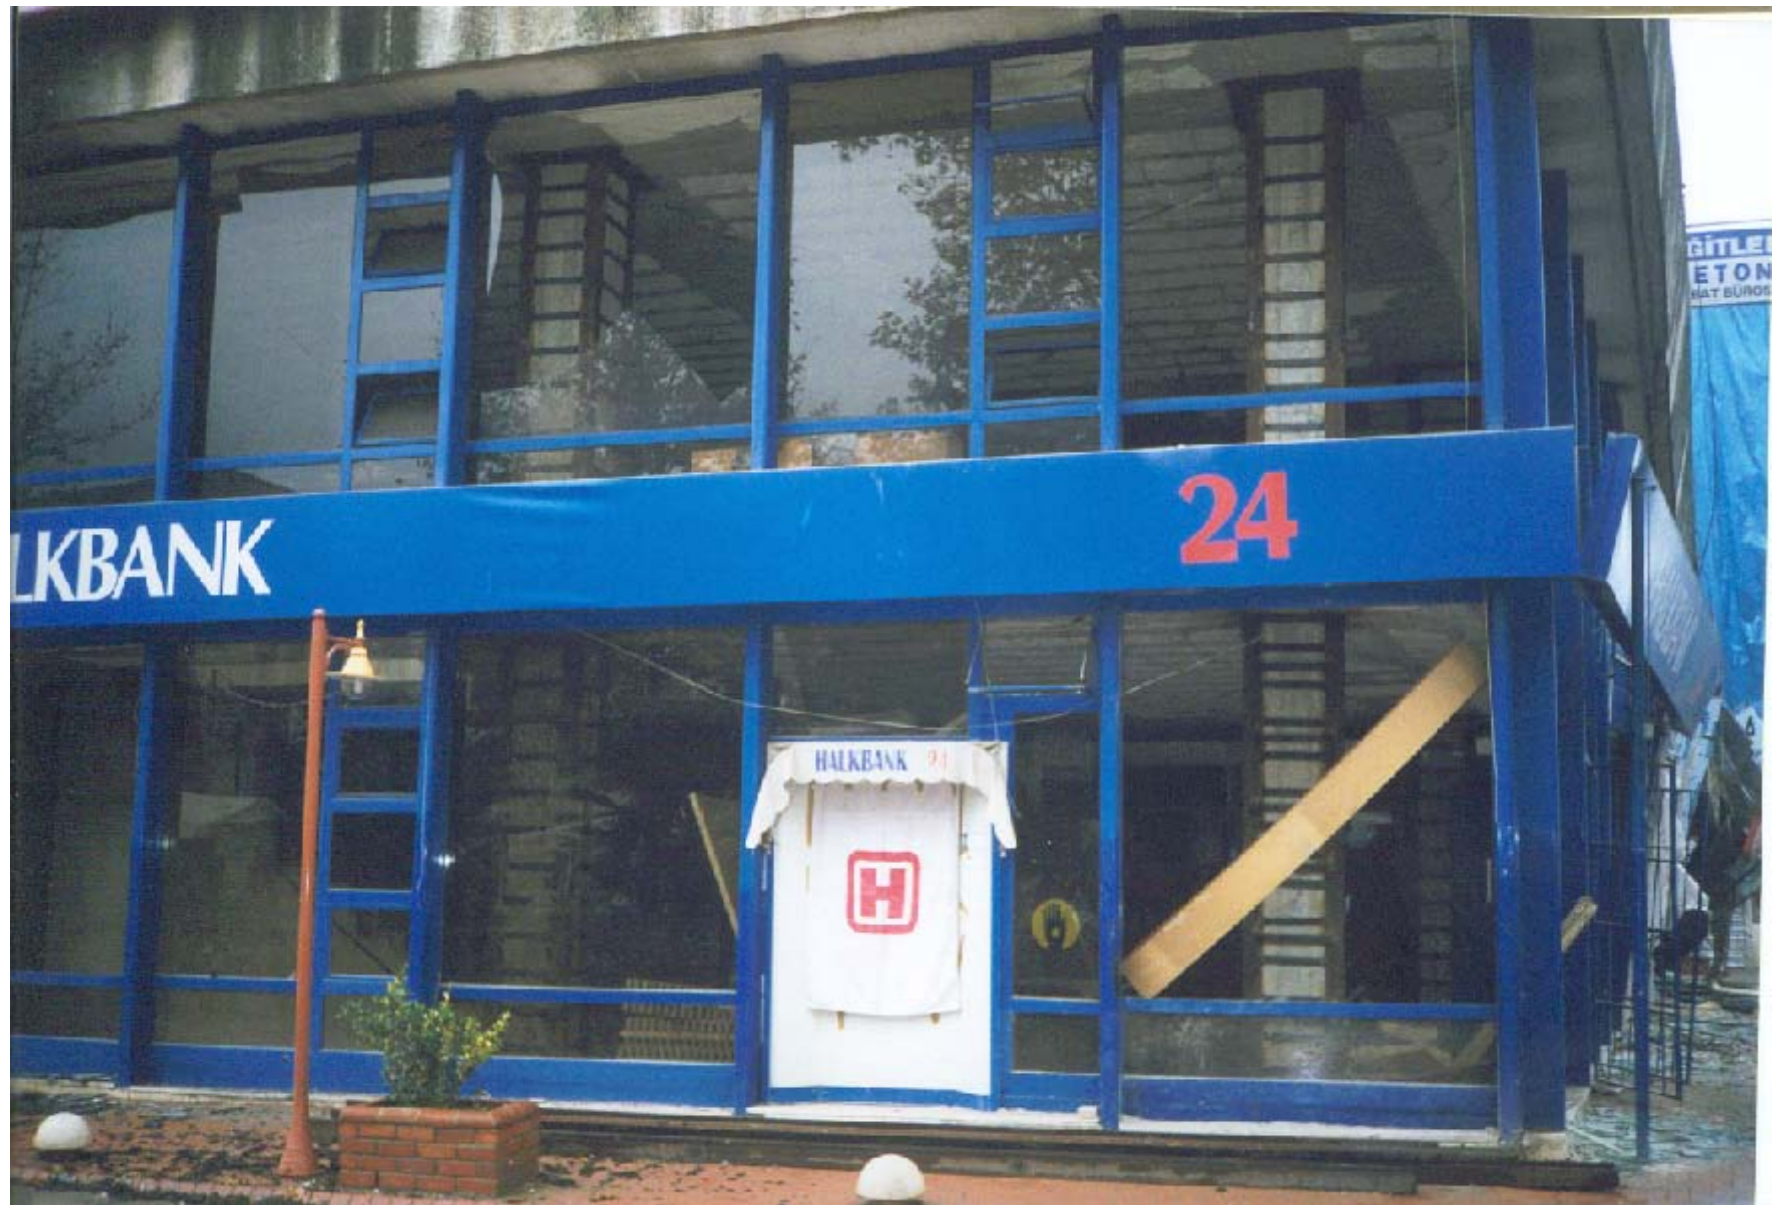
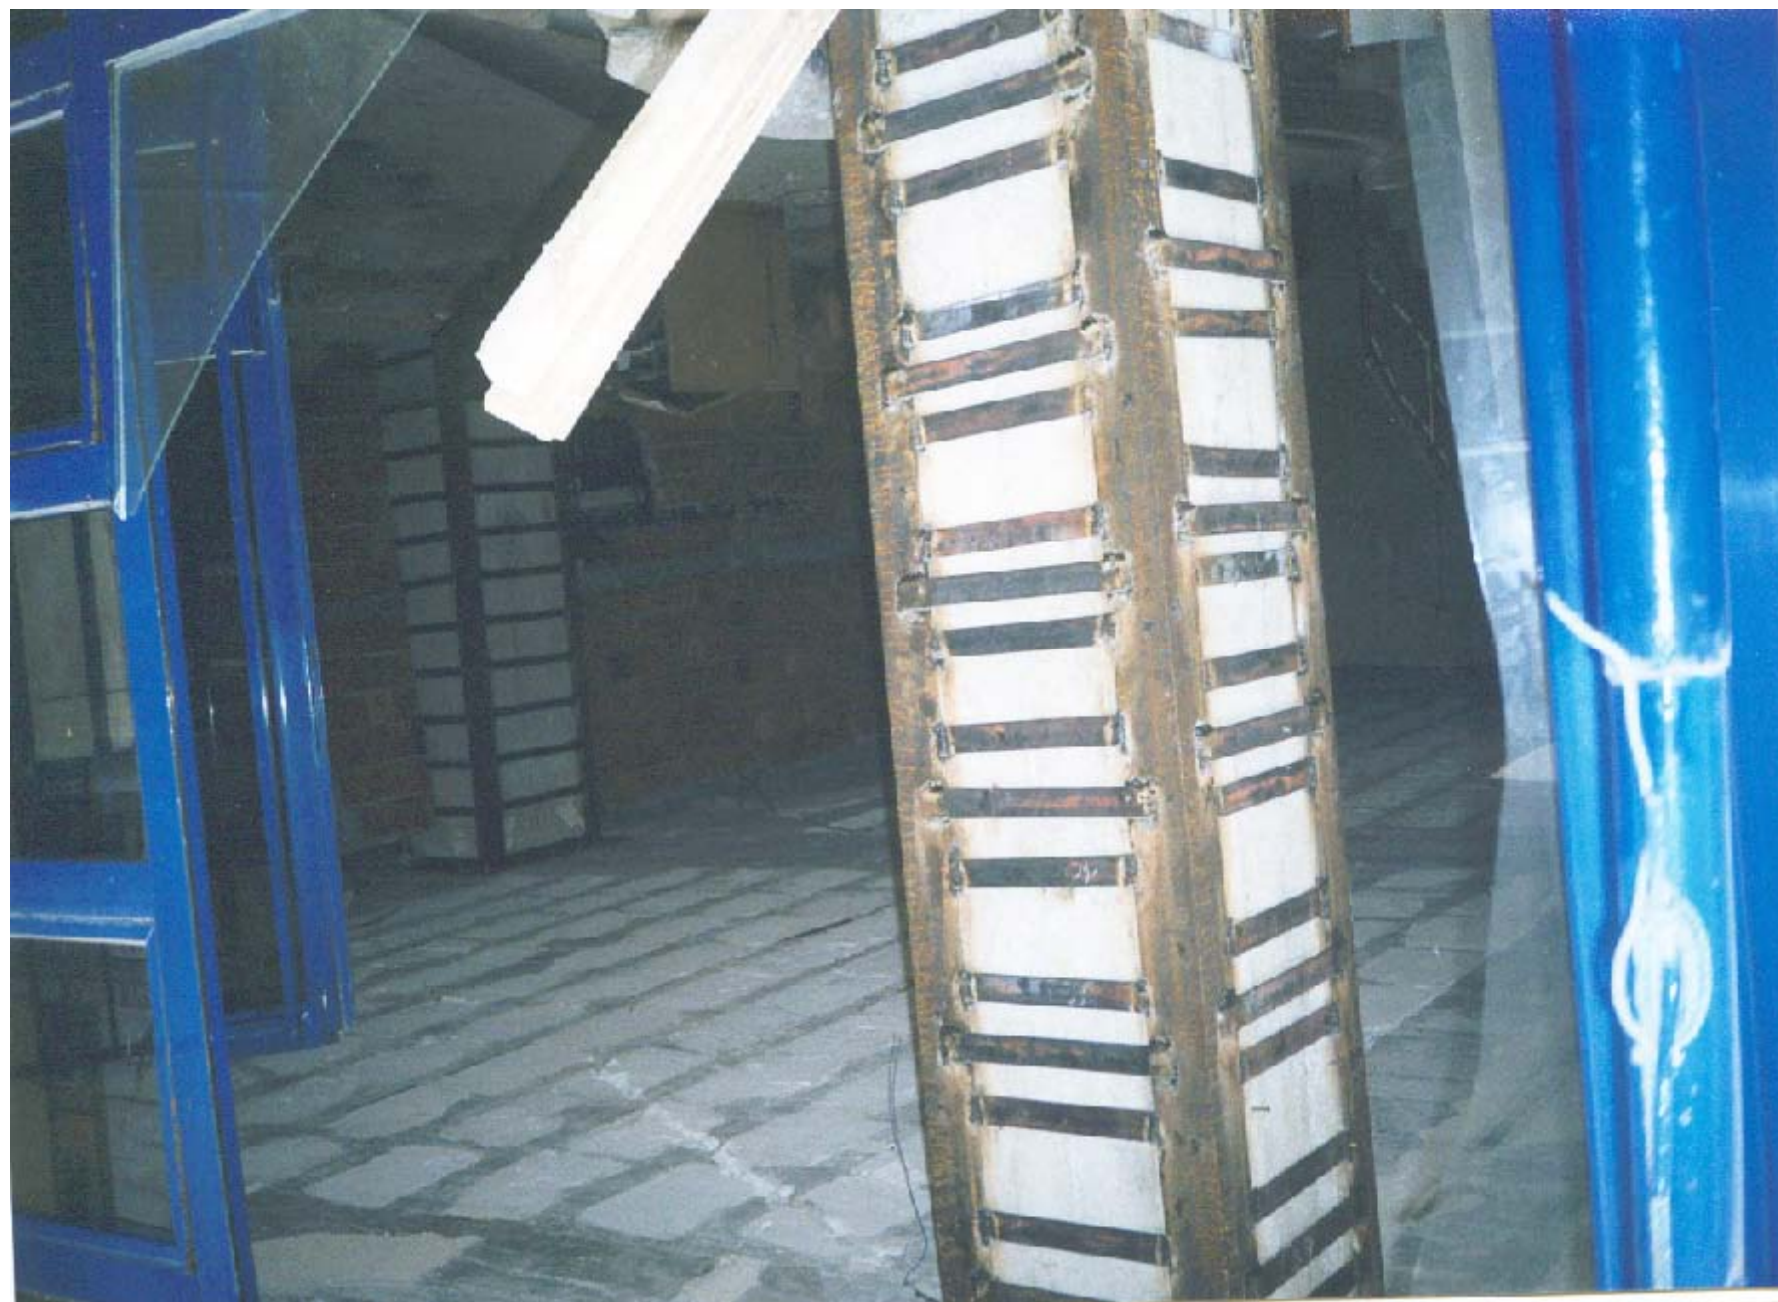
# COMMERCIAL BUILDING in DUZCE (NOT designed by professionals, wrong repairing)

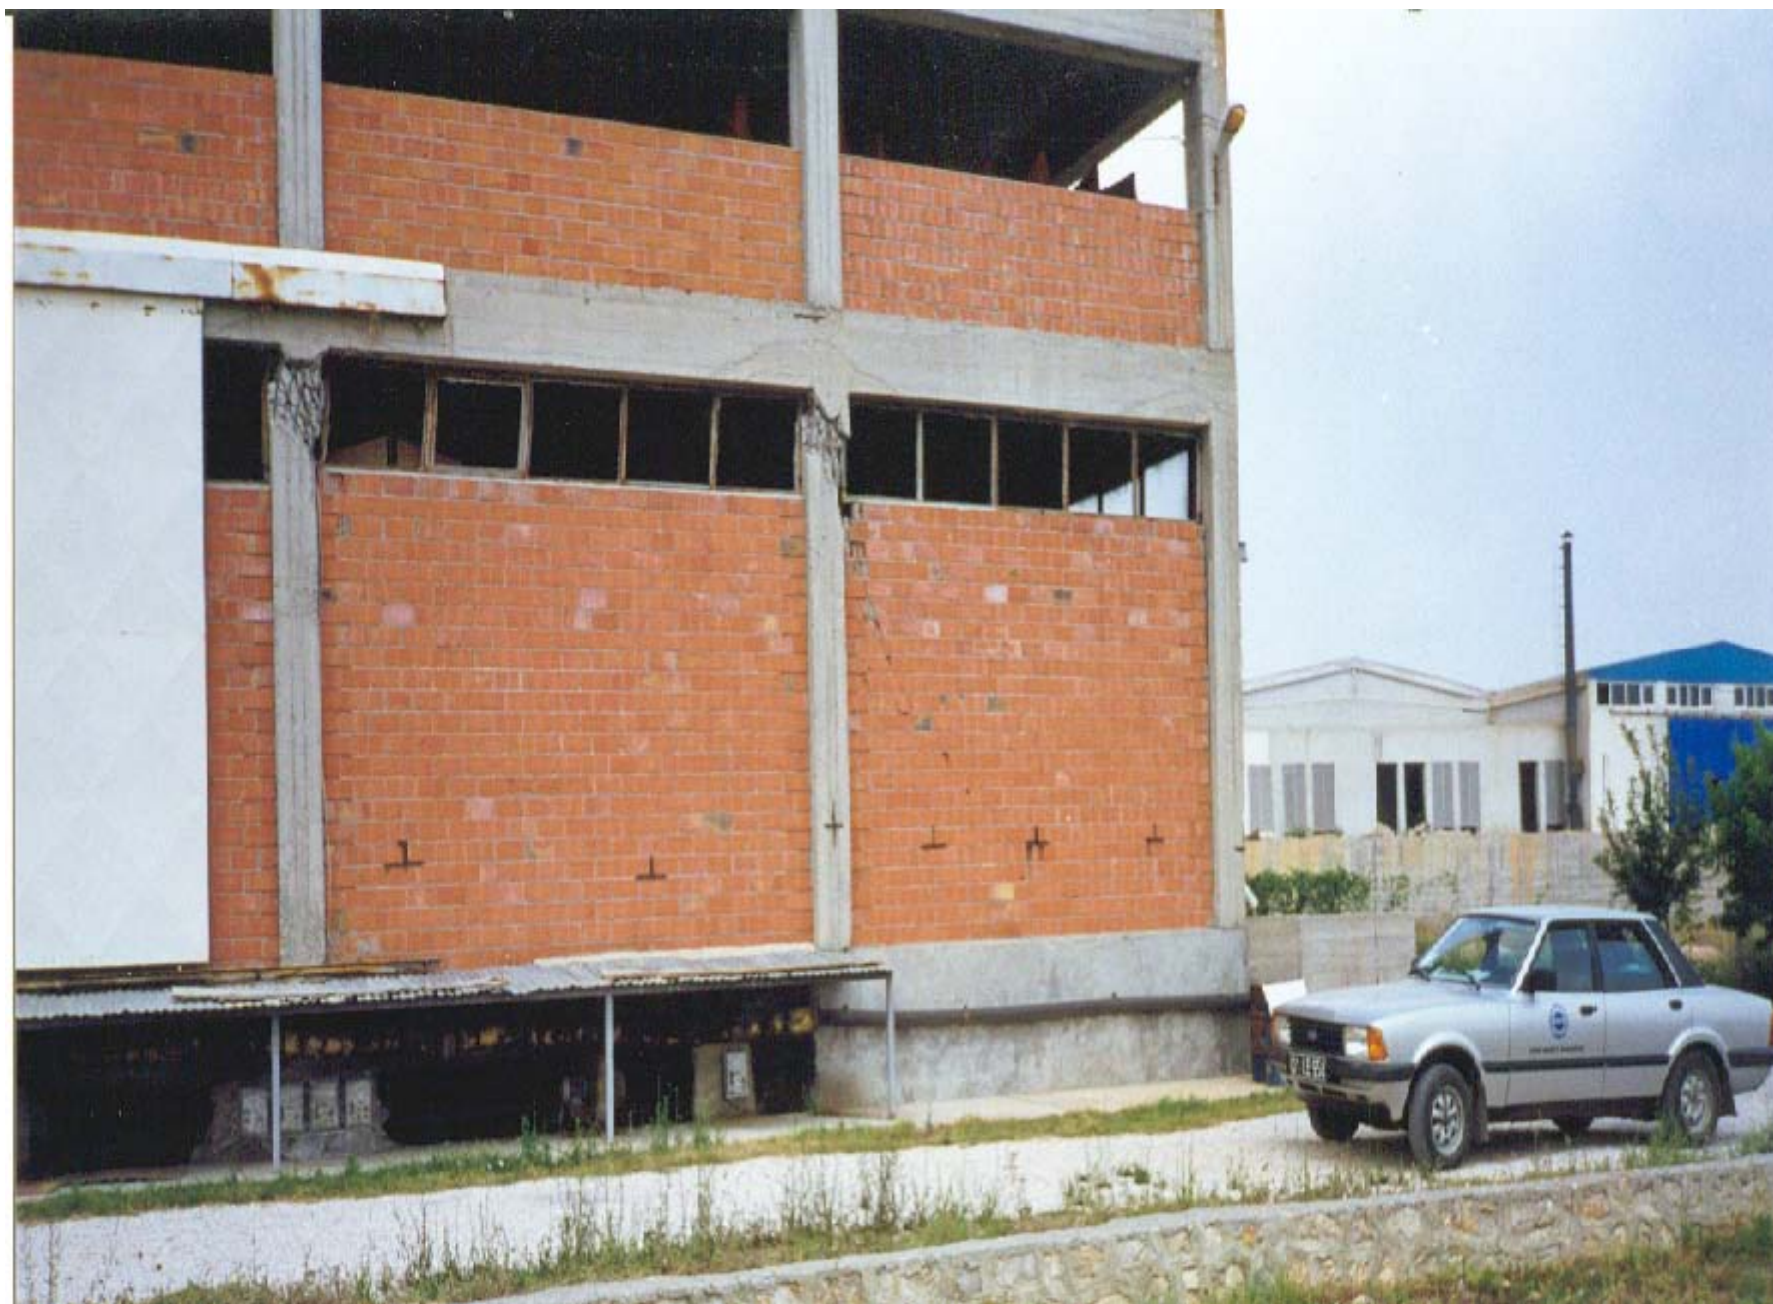
# SHORT COLUMN EFFECT
