## SUMMARY REPORTS of RECENT EARTHQUAKES inTURKEY

**Prof. Dr. Nesrin YARDIMCI**  
**Assist. Prof. Dr. Pınar ÖZDEMİR**  
**Res. Assist. Cüneyt VATANSEVER**

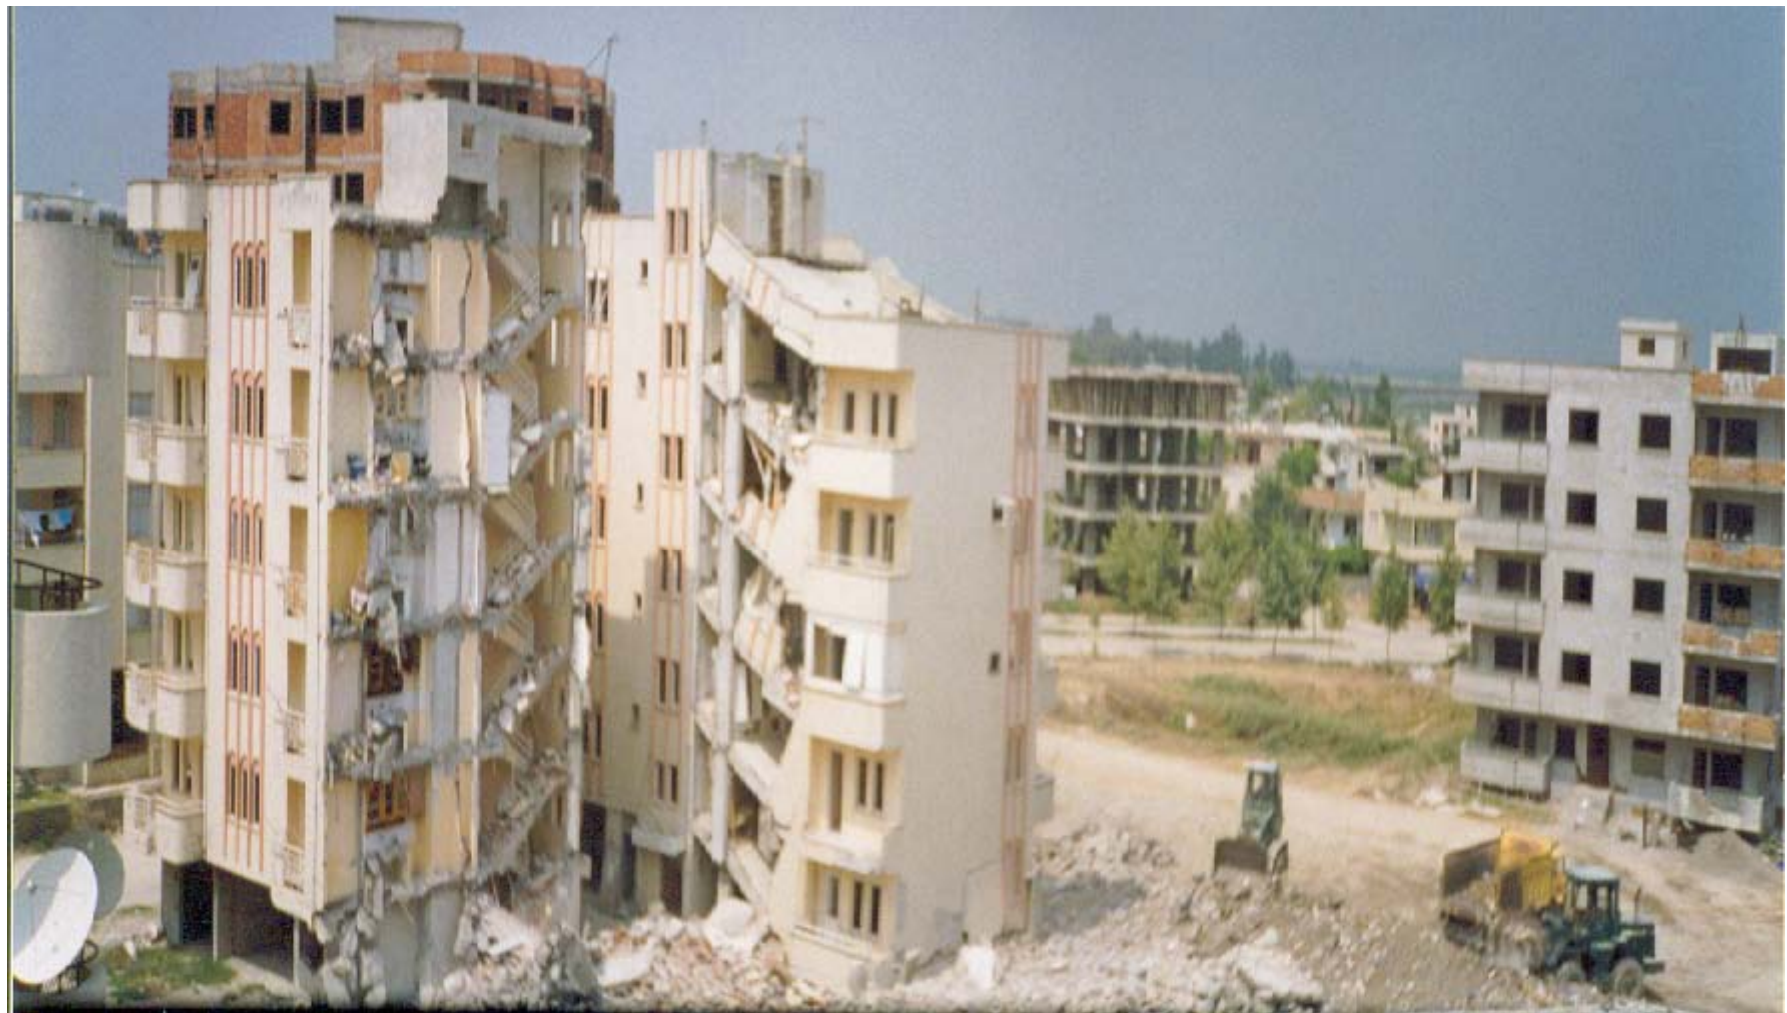
In general, most of the new mid-rise and tall buildings in Adana (5-15 stories) performed well. The buildings damaged and/or collapsed in Adana were older and shorter. Most of the reinforced concrete buildings collapsed during the earthquake located in Ceyhan city. Many RC buildings had a damage of separation of infill walls from the frame, X-cracks of infill walls, some column damage due to insufficient concrete cover.

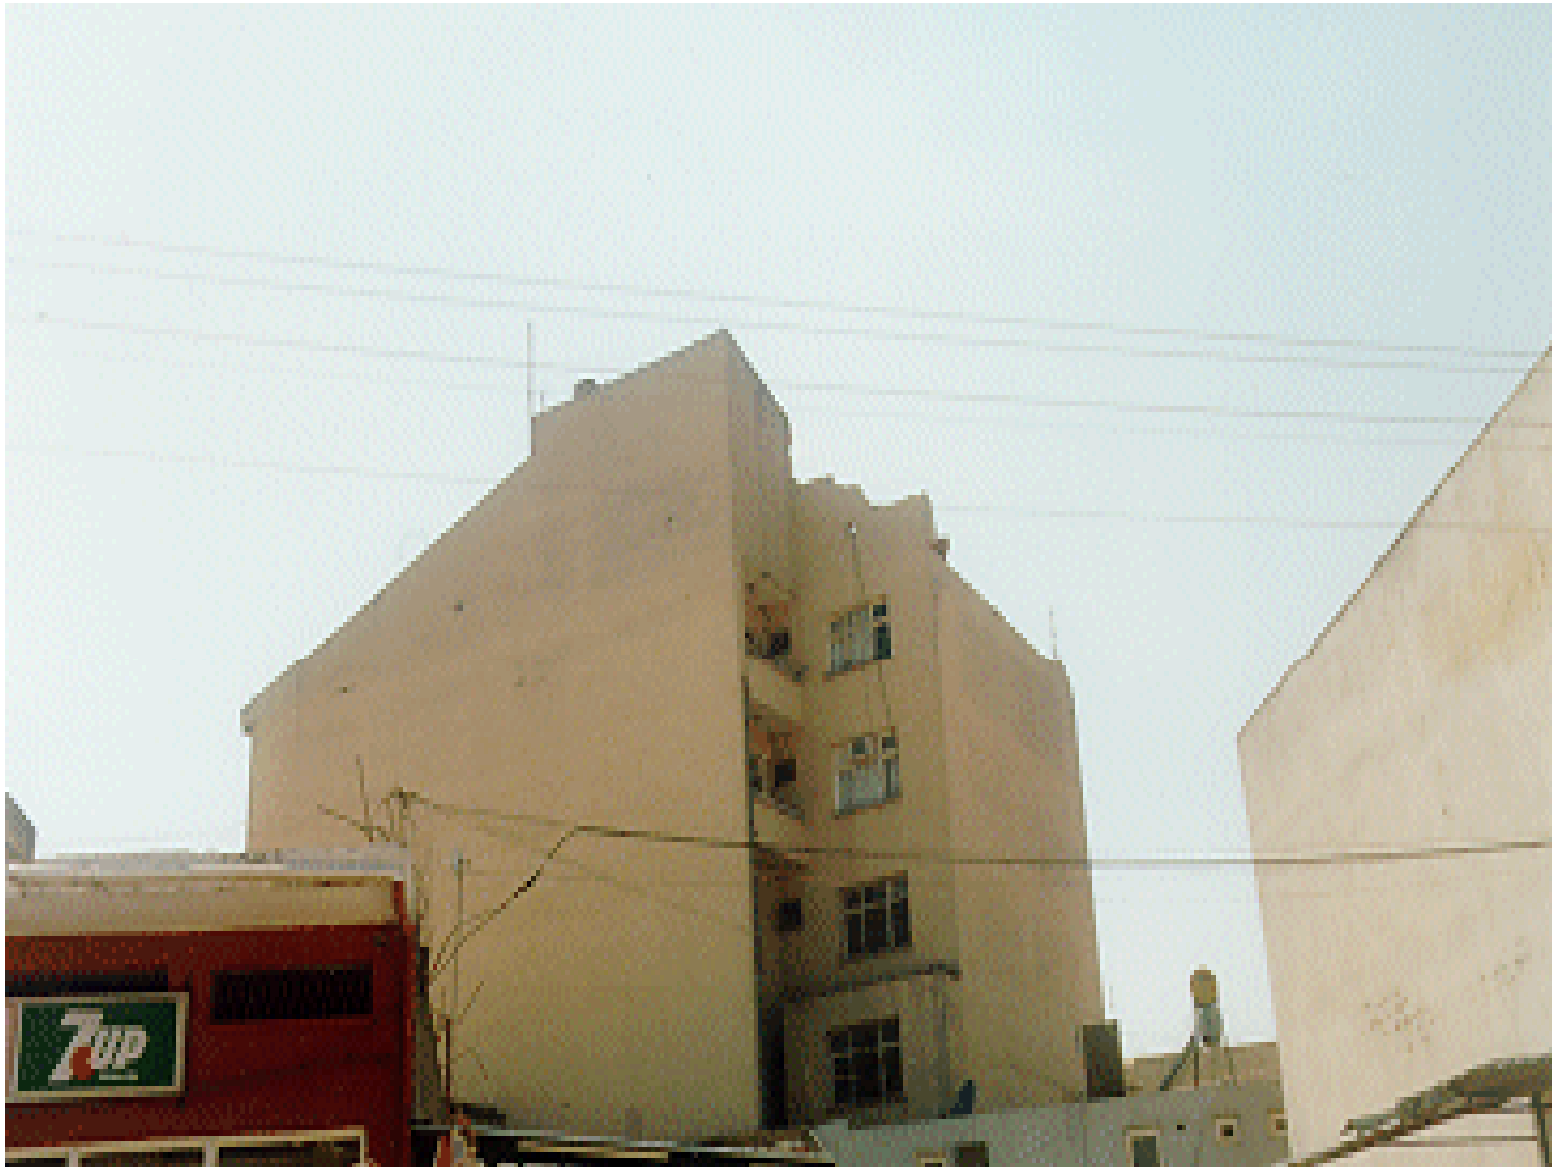
**Collapsed Gable and Parapet Wall of The Police  
Headquarters ( Bayulke,1998 )**

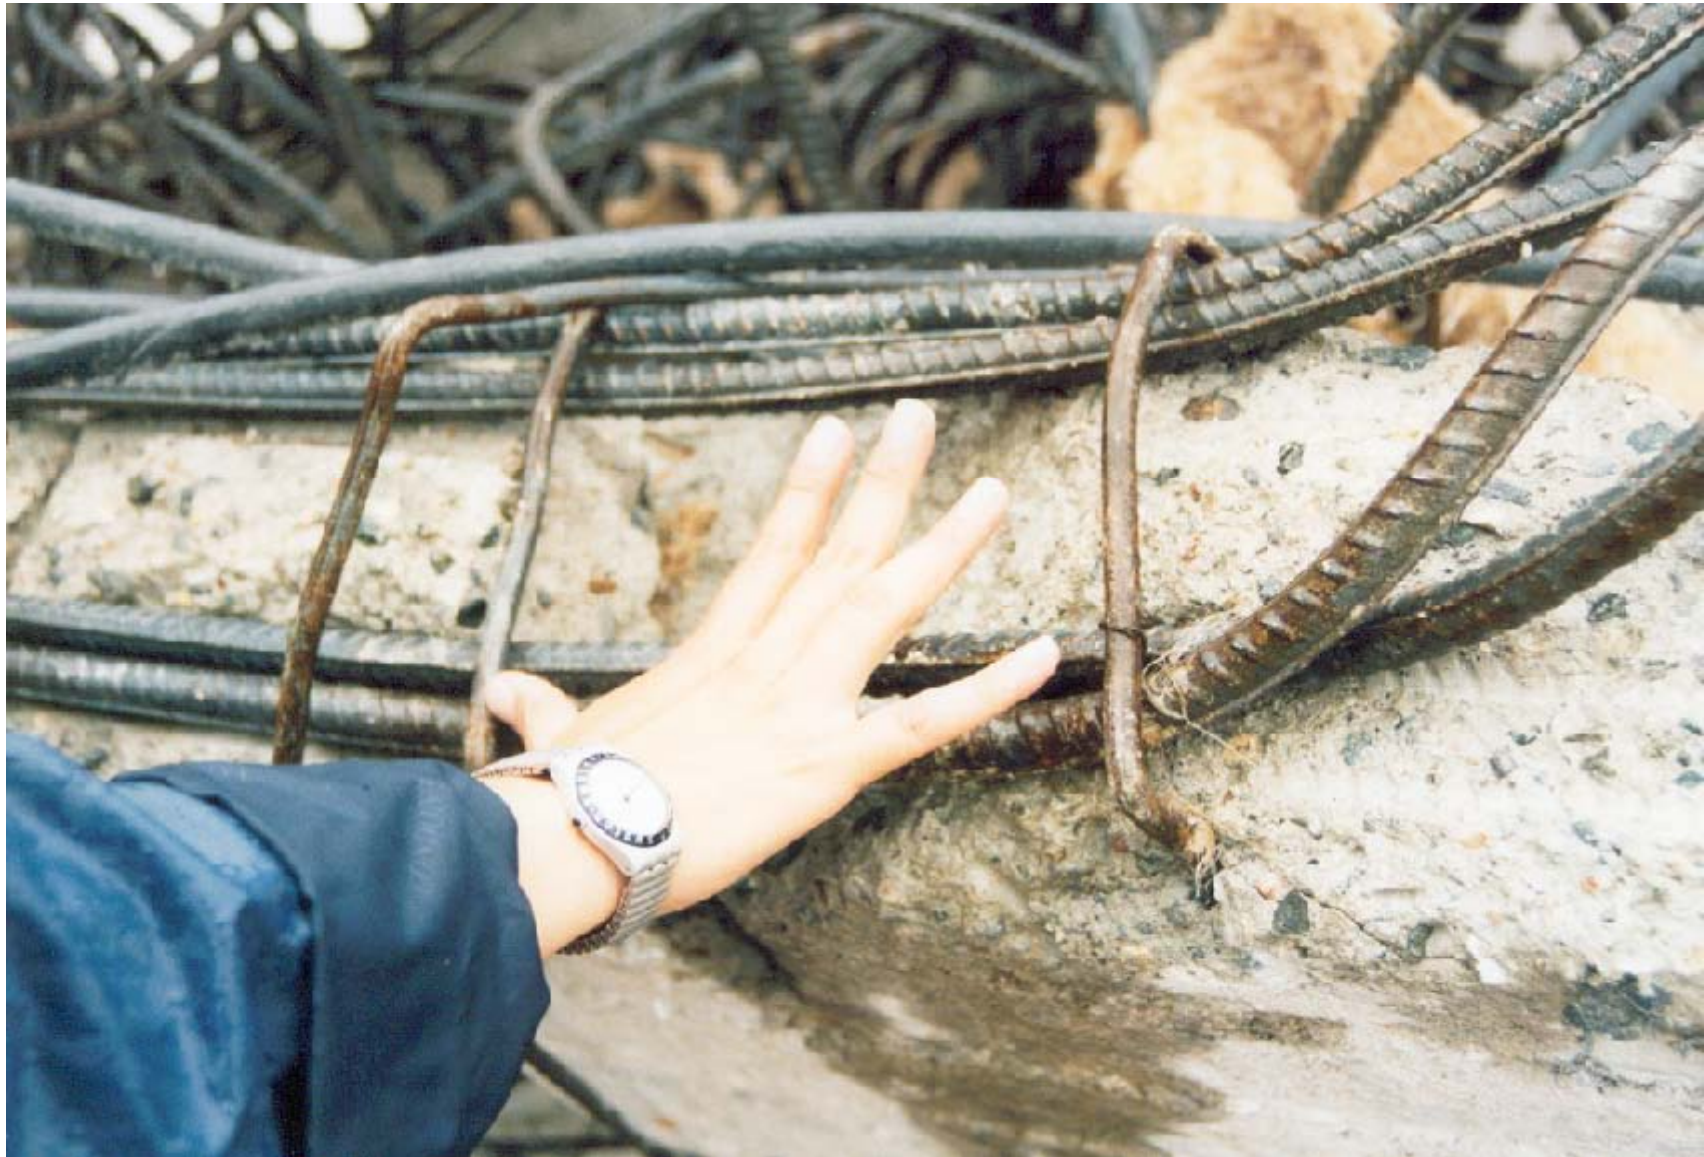
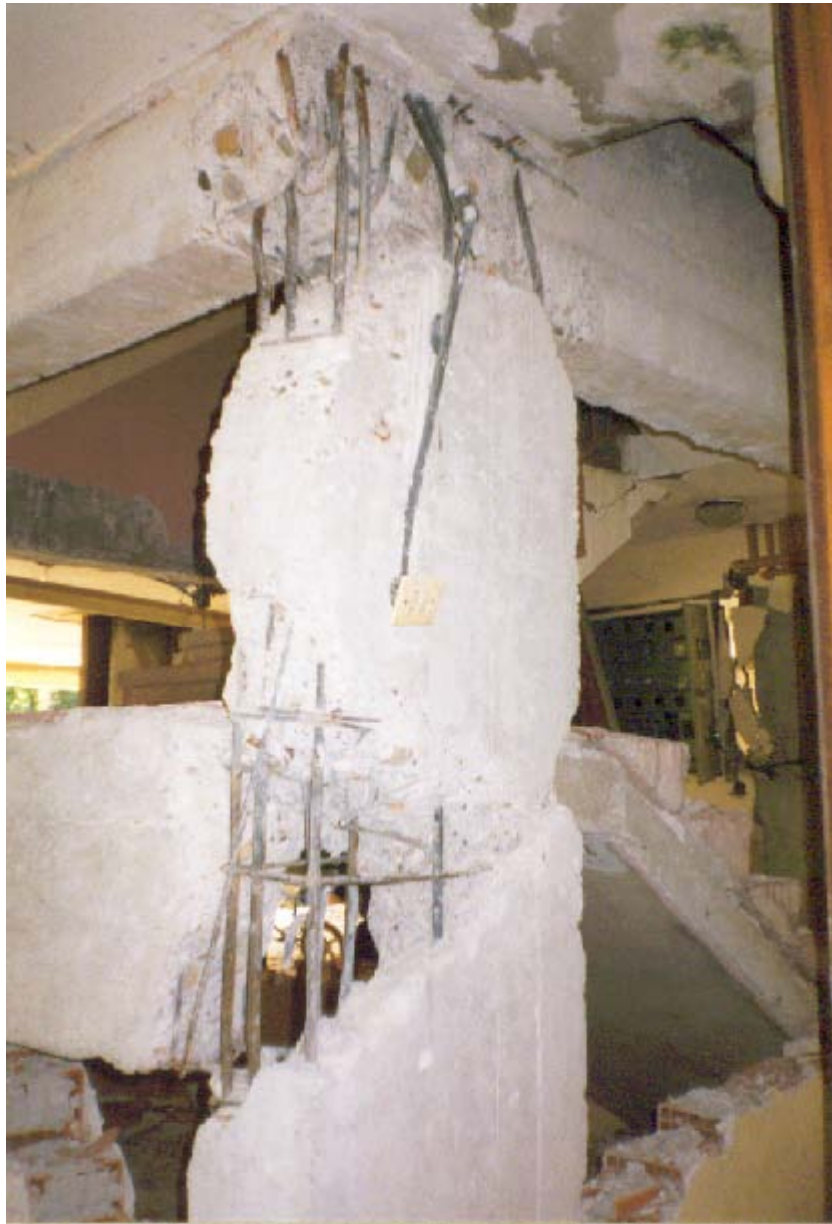
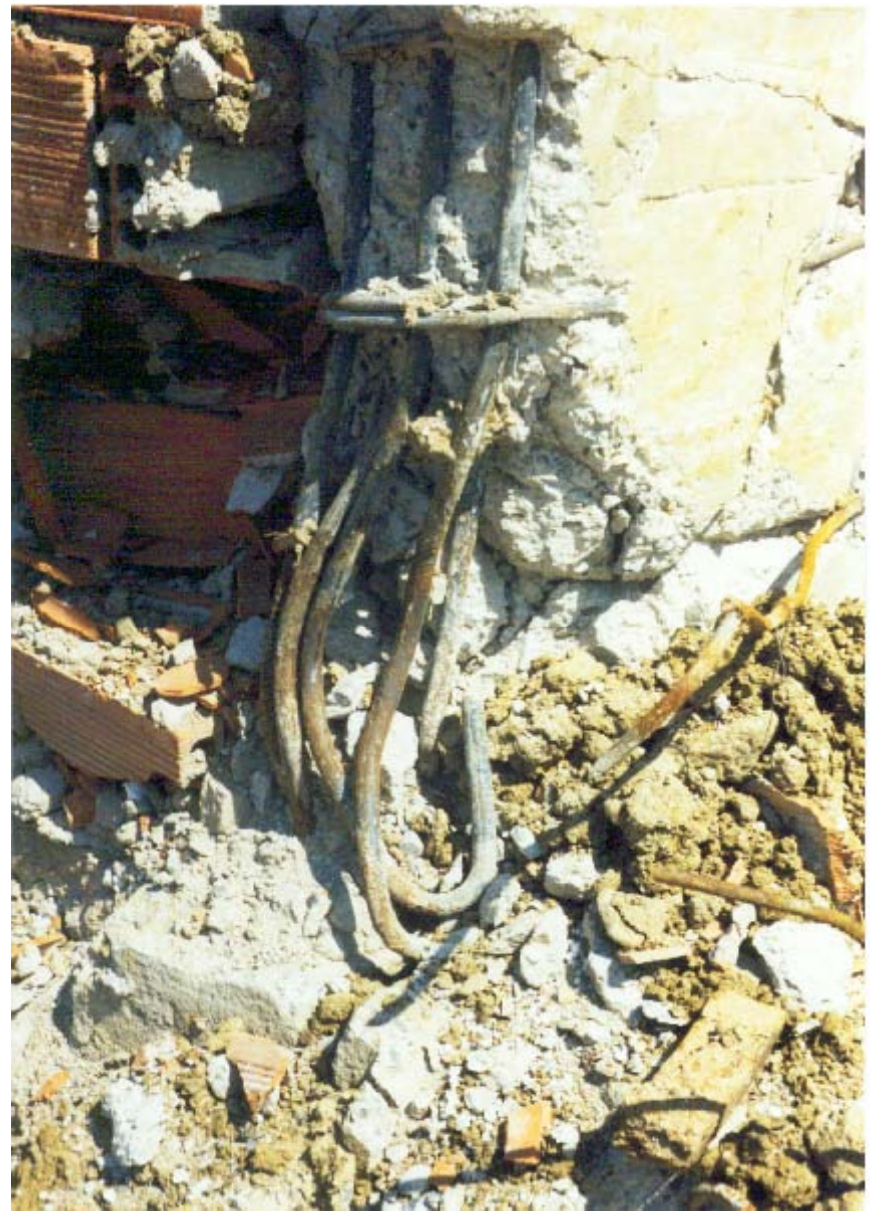
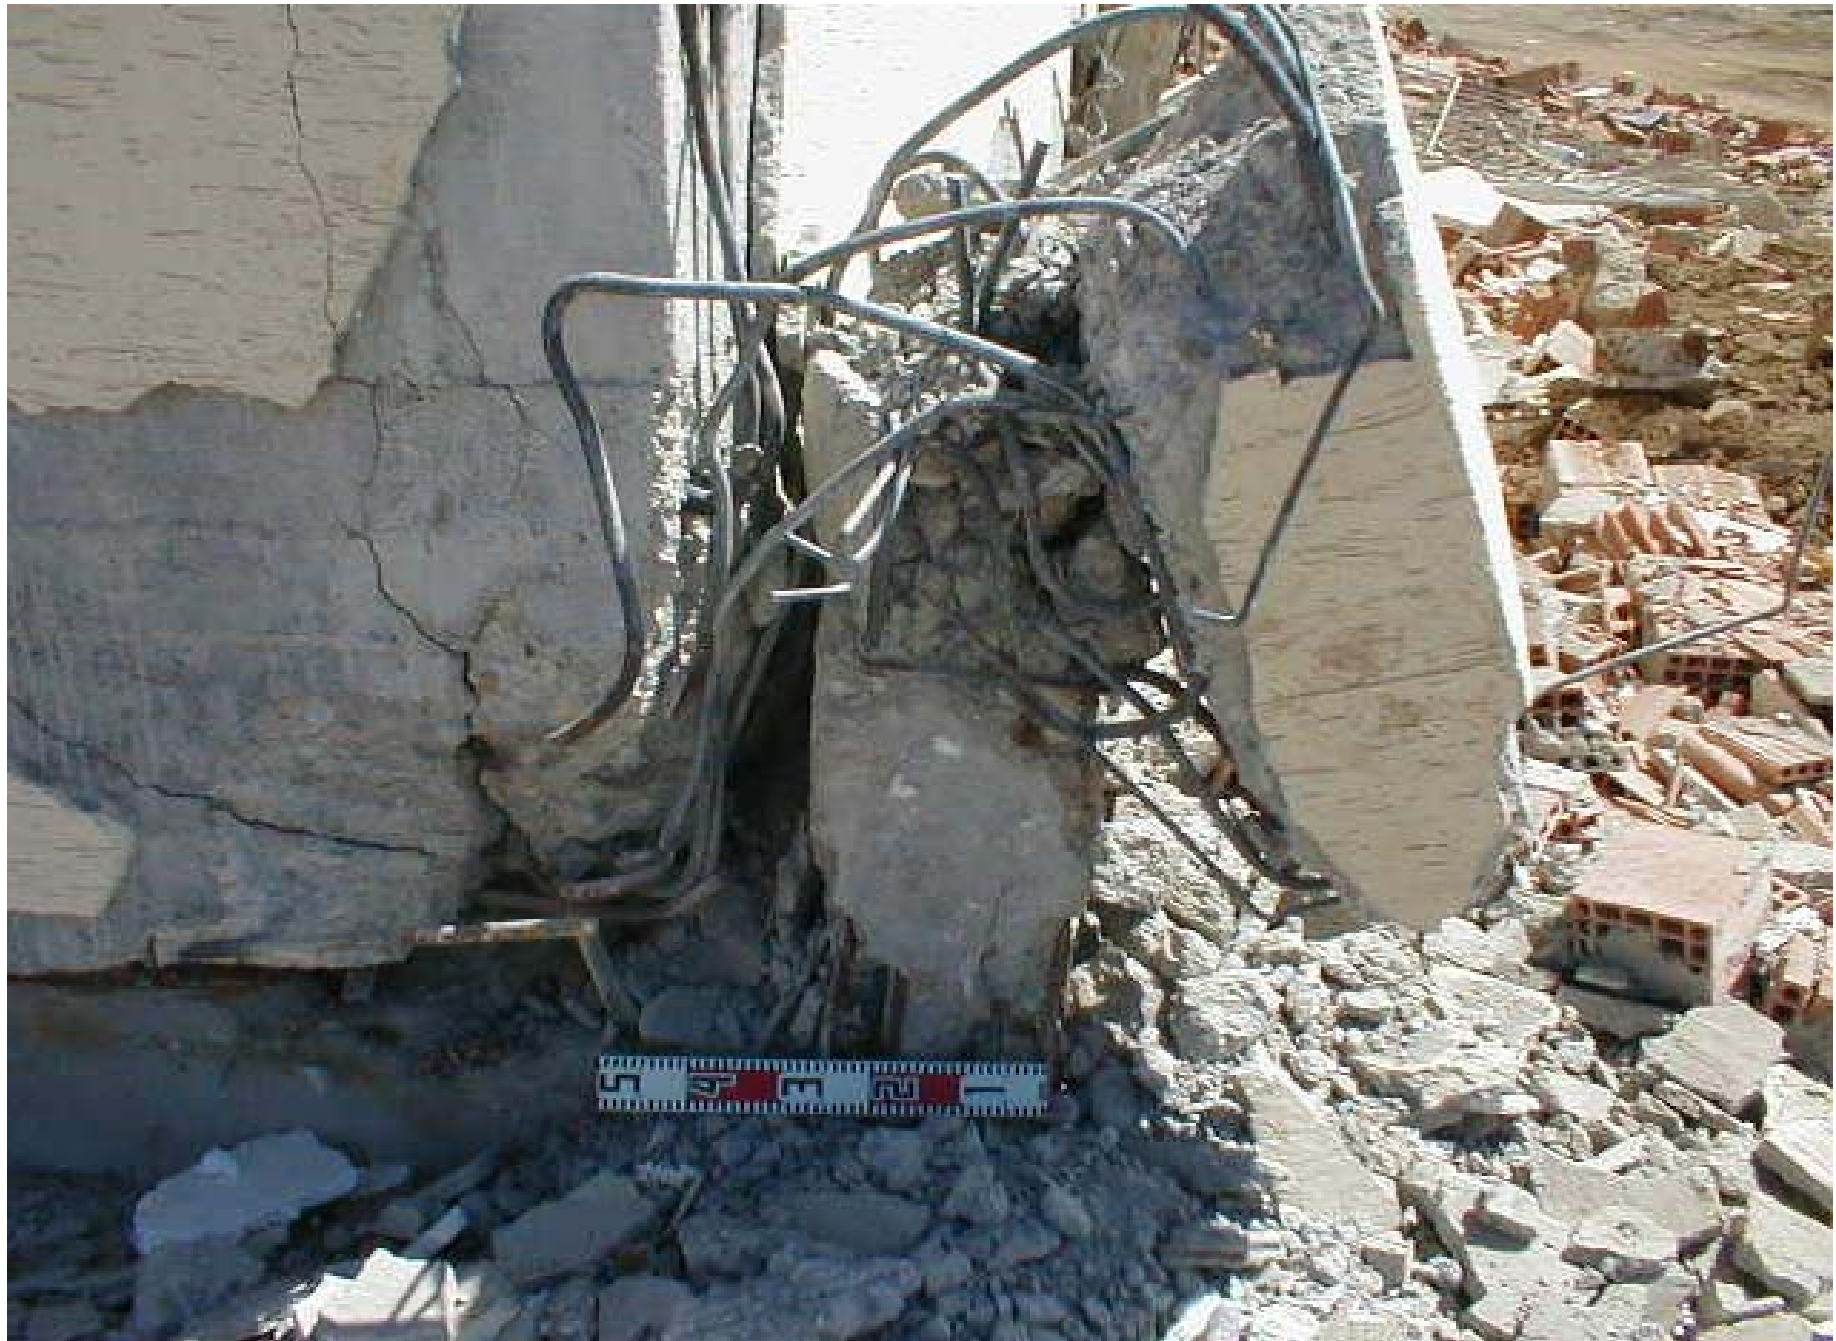
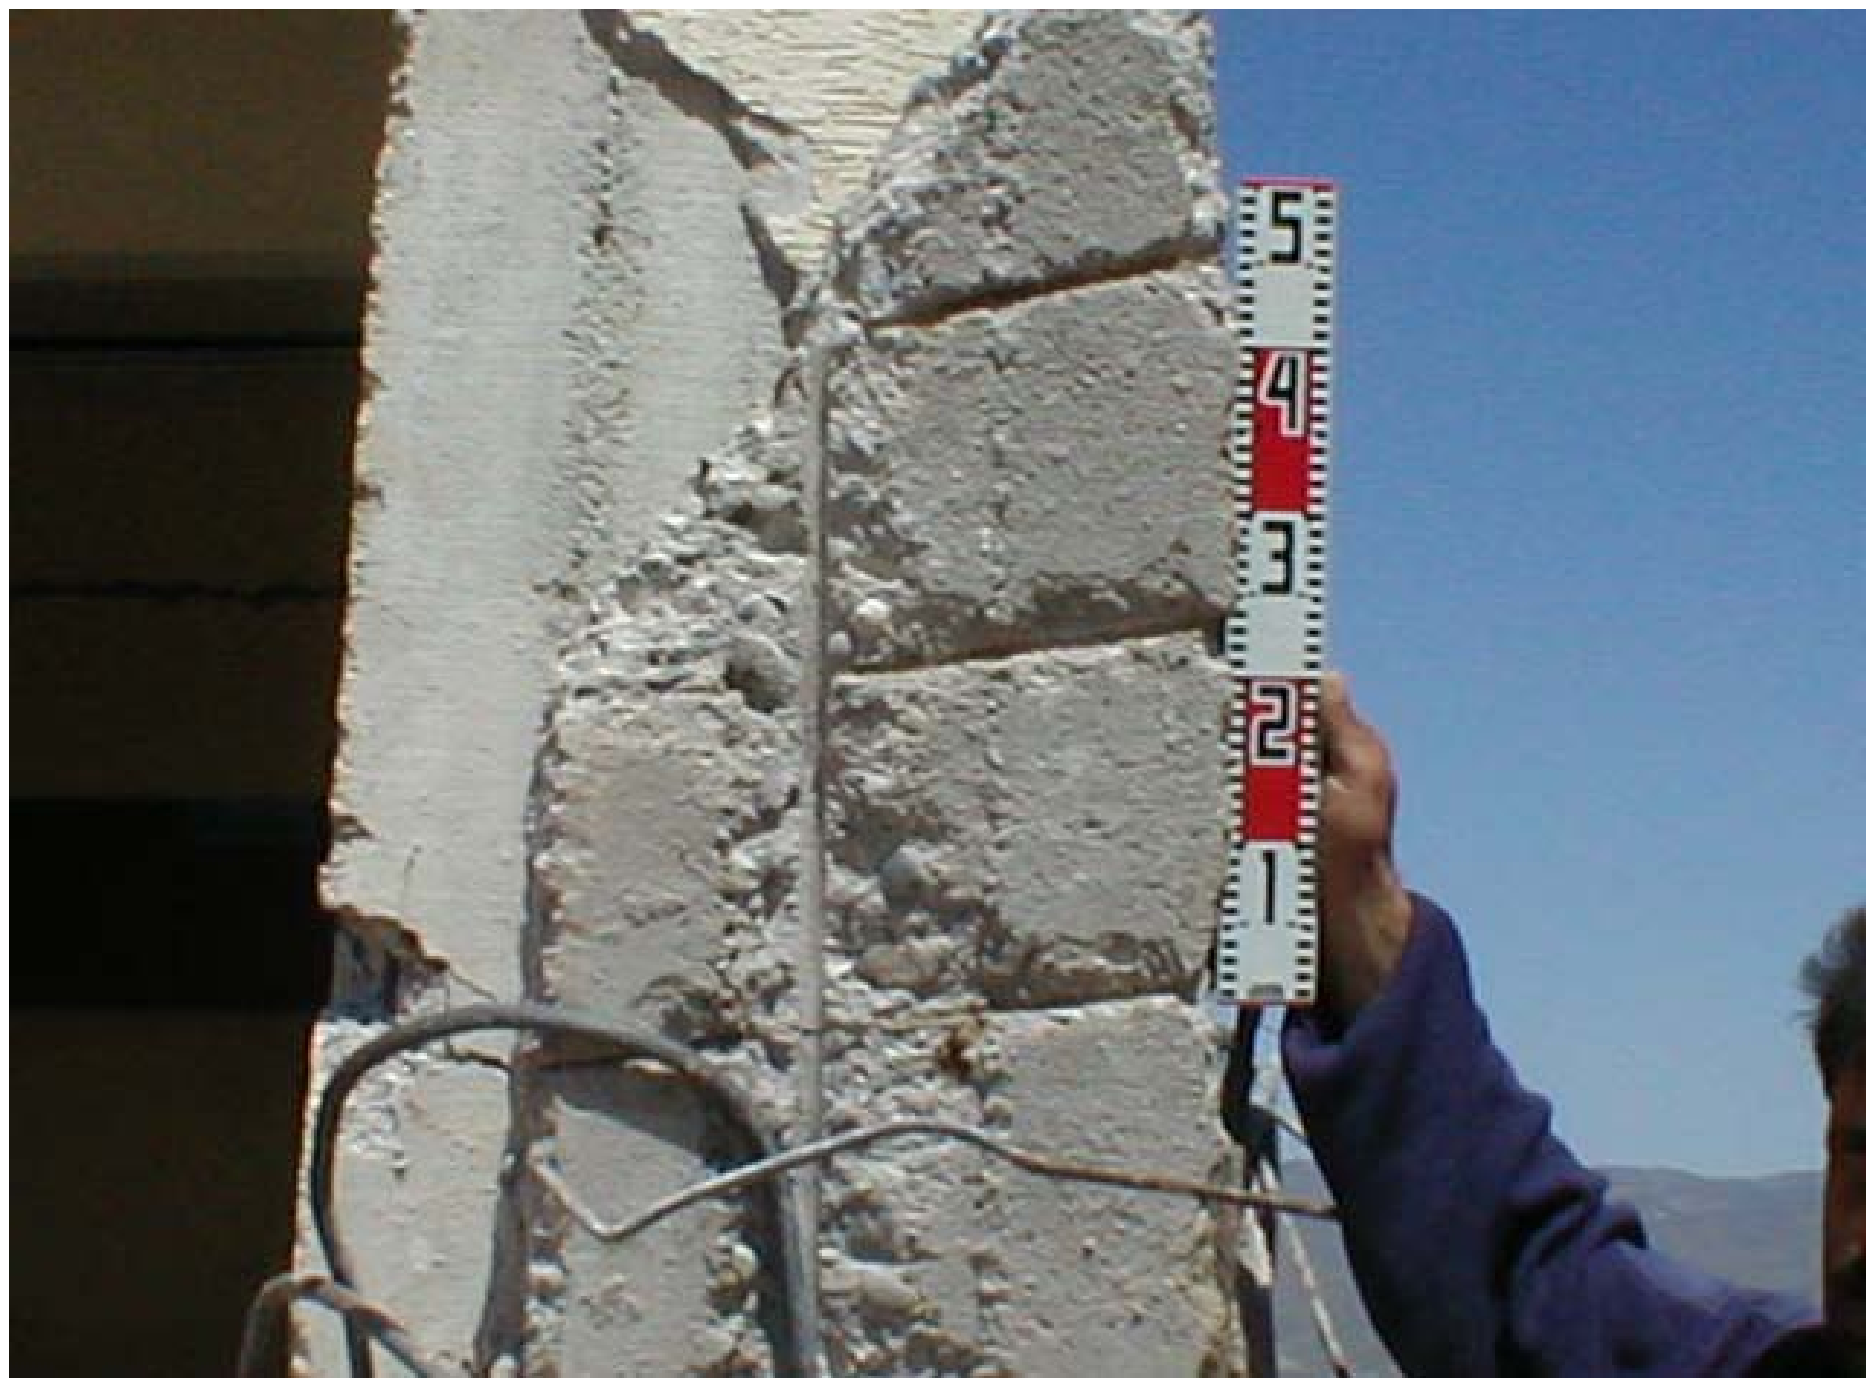
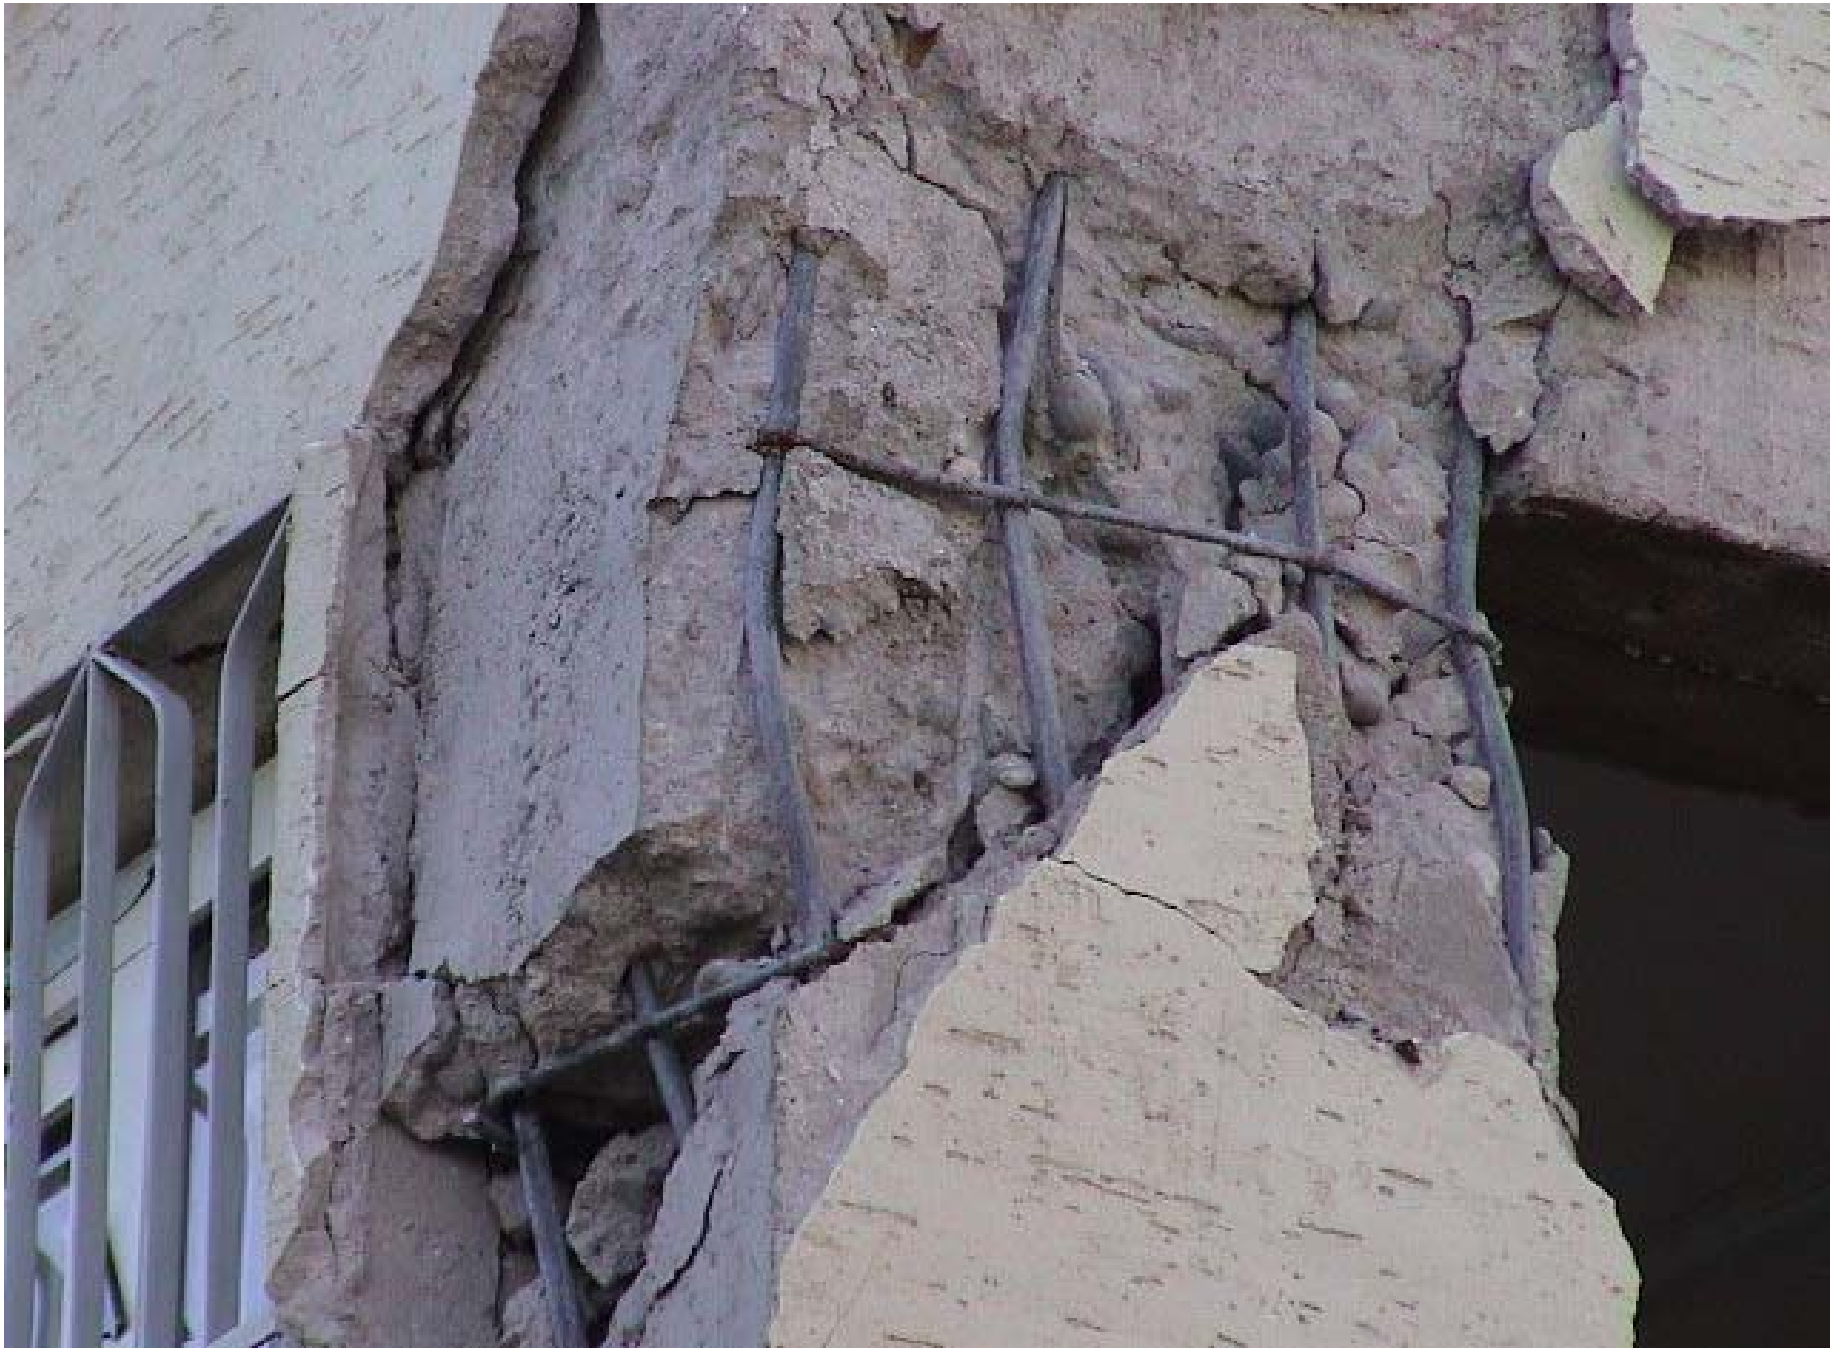
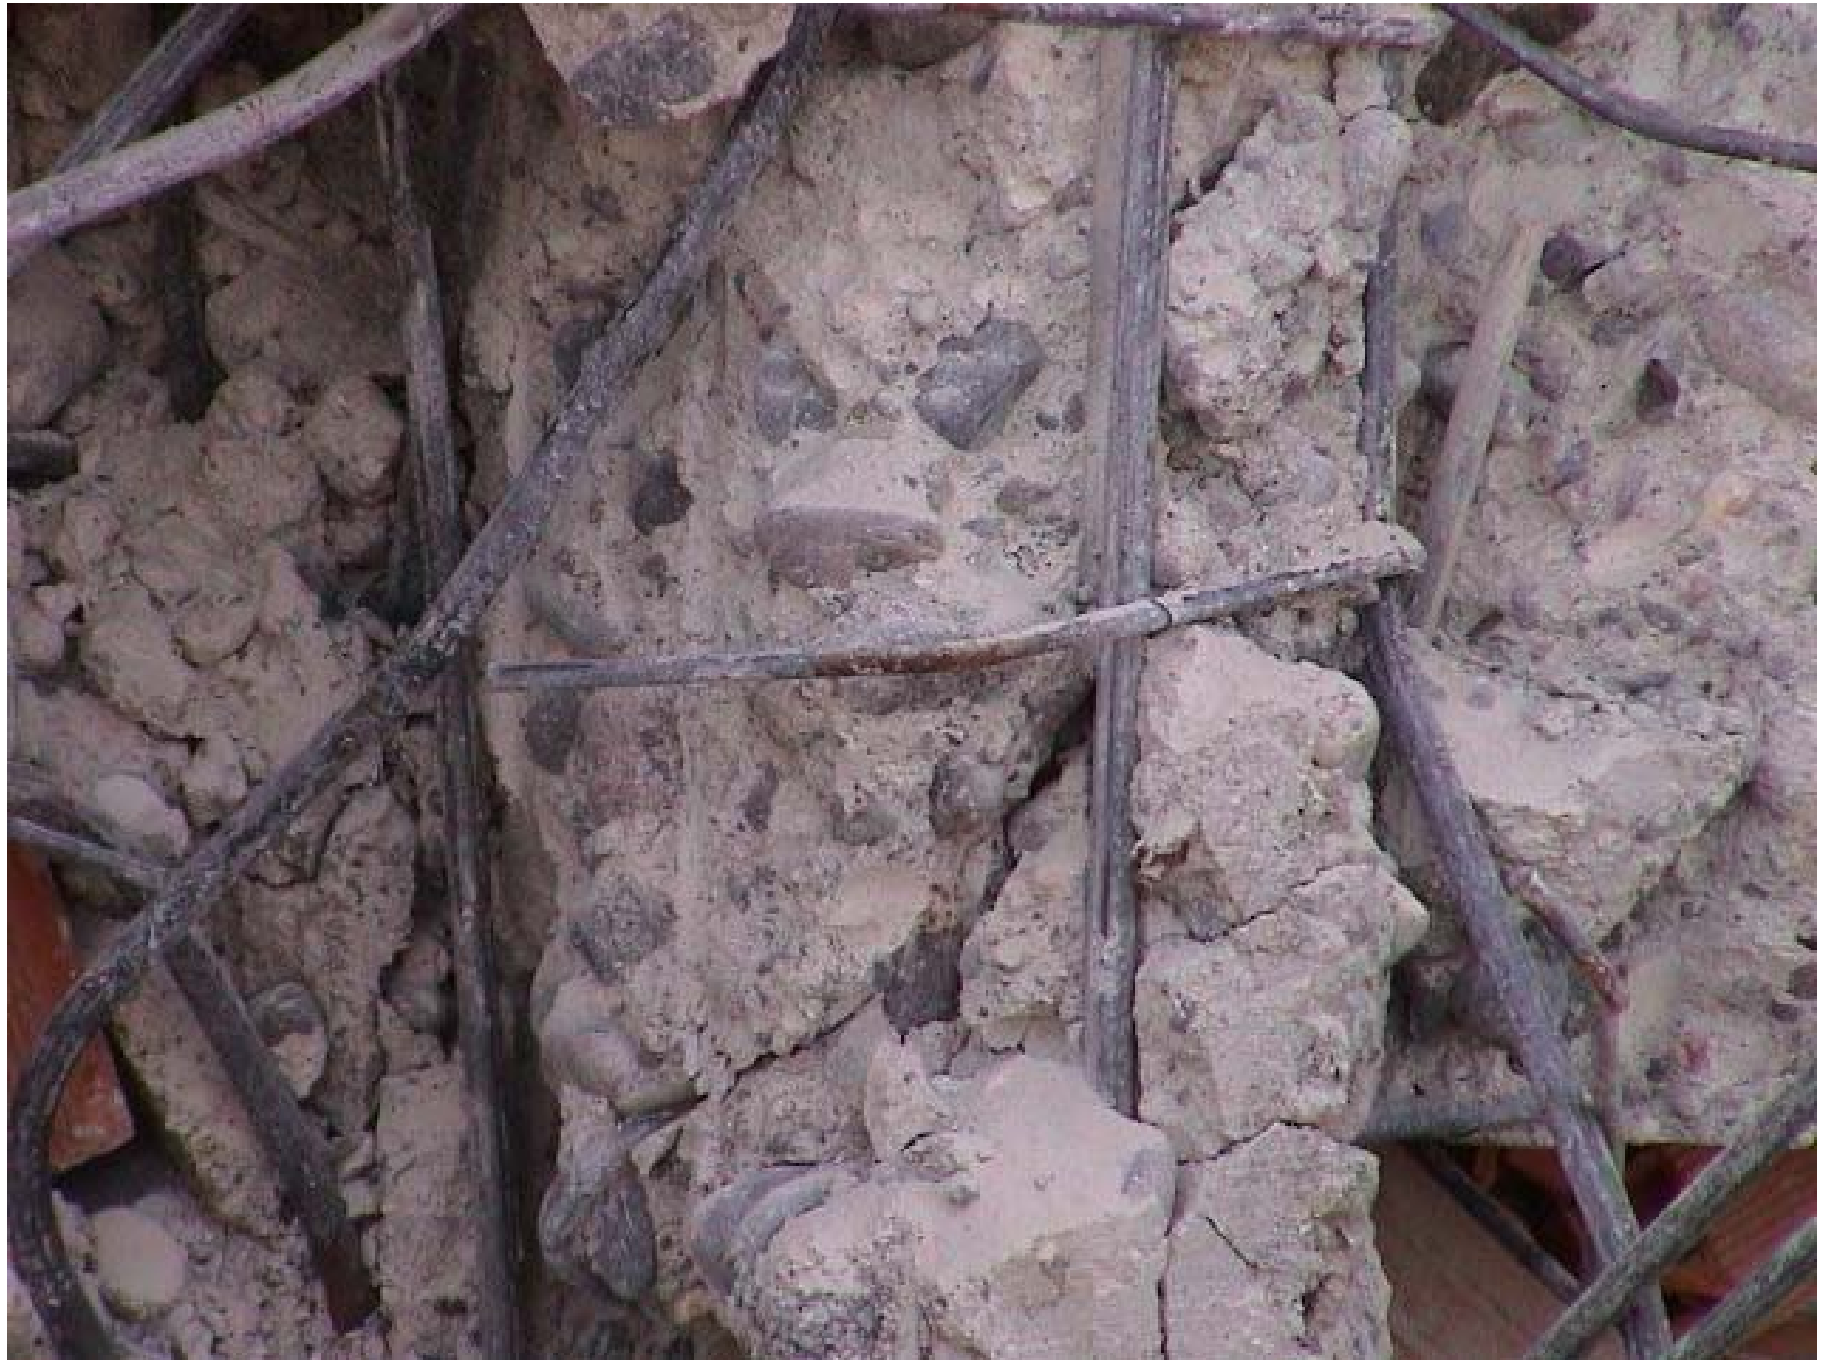
## **SOME EXAMPLES FOR DAMAGED CONNECTIONS and INADEQUATE DETAILS in R-C BUILDINGS**

1. Poorly designed, for example,
  - NOT designed by professionals!!
  - soft first story,
  - inadequate detailing and reinforcements of column-beam connections and columns,
  - design of strong beam/weak columns rather than strong-column/weak beams,
  - creation of short-columns due to infill walls or offsets in design,
  - inadequate details,
2. Lack of inspection and supervision at the design and construction stages,
3. Questionable quality of materials used,
4. Bad workmanship,
5. Site effects.
